Review of a completed Decommissioning Project :

The Eurochemic Reprocessing Plant in Belgium

Bart Ooms and Robert Walthéry
November 10 2015

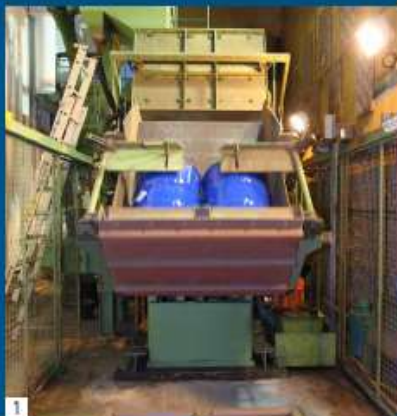
1
LAADENHEID VAN DE STRAALINSTALLATIE
CHARGING DEVICE OF THE BLASTING INSTALLATION

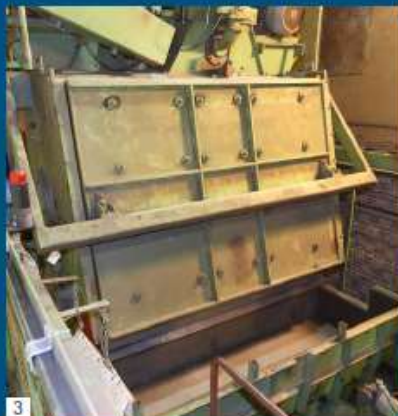
3
GESLOTEN STRAALTROMMEL
CLOSED BLASTING CHAMBER

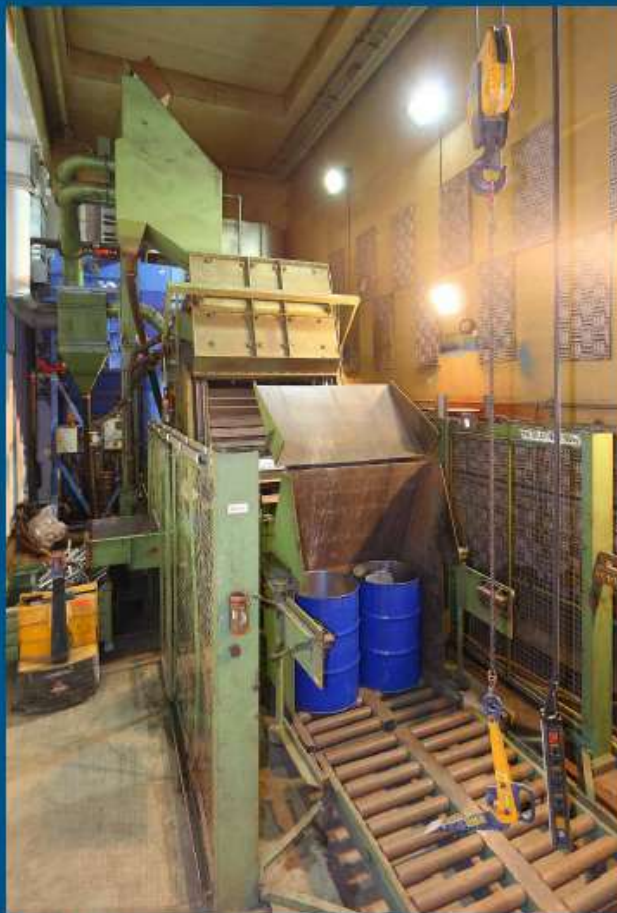
GLOBAAL BEELD VAN DE STRAALINSTALLATIE
OVERVIEW OF THE BLASTING INSTALLATION

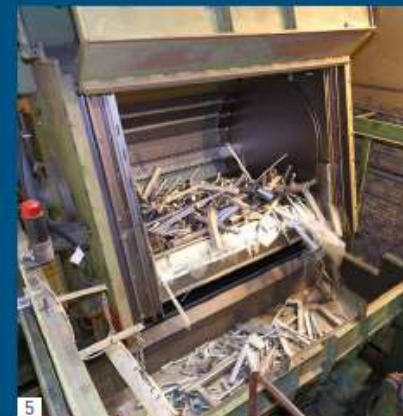
5
ONTLADEN VAN DE STRAALTROMMEL
DISCHARGE OF THE BLASTING CHAMBER

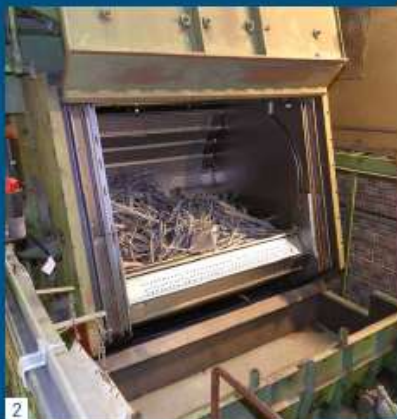
2
GEOPENDE STRAALTROMMEL MET TE STRALEN METAAL
OPENED BLASTING CHAMBER WITH METALS TO BE DECONTAMINATED

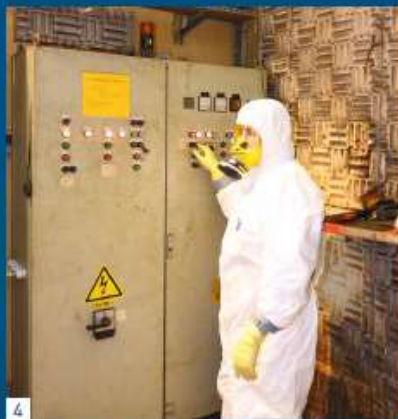
4
BEDIENING VAN DE STRAALINSTALLATIE
OPERATION OF THE BLASTING INSTALLATION

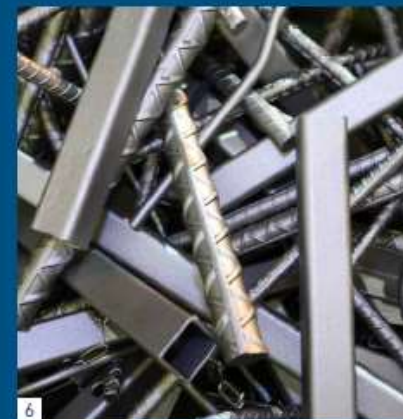
6
GESTRAALD METAAL
BLASTED METAL
